## **DETERMINATION OF THE CONTENT AND COMPOSITION OF INCLUSIONS IN GUN BARREL STEEL**

Report No.: M410

Date: 06/03/2023

Customer: Zbraně Kuna  
Kampelíkova 297/55  
500 04 Hradec Králové  
Czech Republic

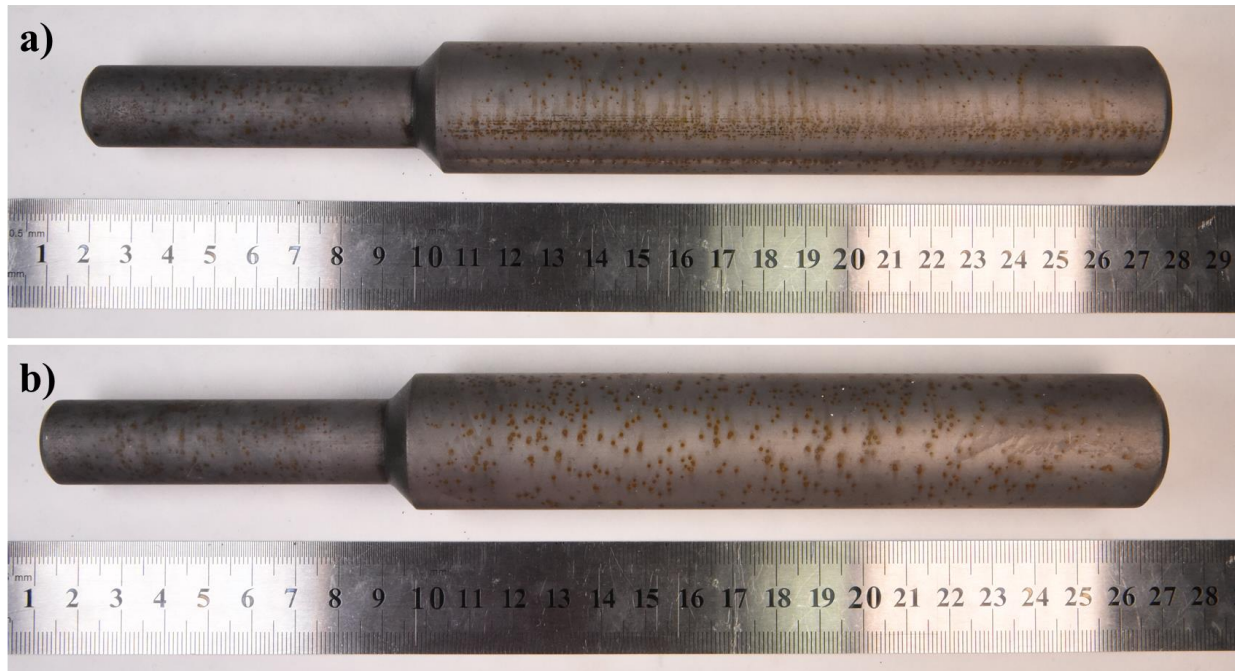
A piece of gun barrel steel from IMPAX material (Figure 1) was delivered by the customer. Spots of red rust formed during pickling in dilute sulphuric acid were unevenly distributed over the surface. The aim of the work was to determine the morphology and origin of the spots.

**Figure 1.** Delivered rod of gun barrel steel

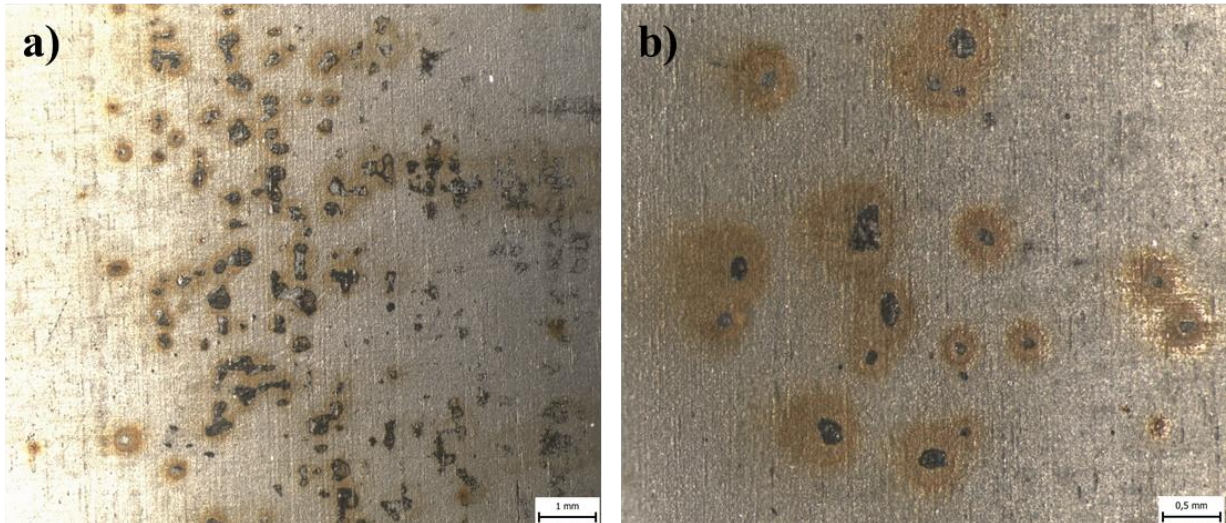
First, an analysis of the pickled surface was carried out. It was found out that the defects were corrosion pits, see Figure 2. Surrounding of the pits was discoloured with corrosion products. The pits were present over the entire surface with uneven distribution. The diameter of the pits was determined to vary over a wide range from 80 to 450  $\mu\text{m}$  with an average value  $230 \pm 91 \mu\text{m}$ . The pits were also analysed using SEM-EDS analysis (Figure 3). Results of chemical composition in wt. % are showed in Table 1. The high content for C, Mn and Cr suggests that there were mixed carbides of Fe, Cr and Mn present there.

**Figure 2.** Pits on surface of the delivered steel rod

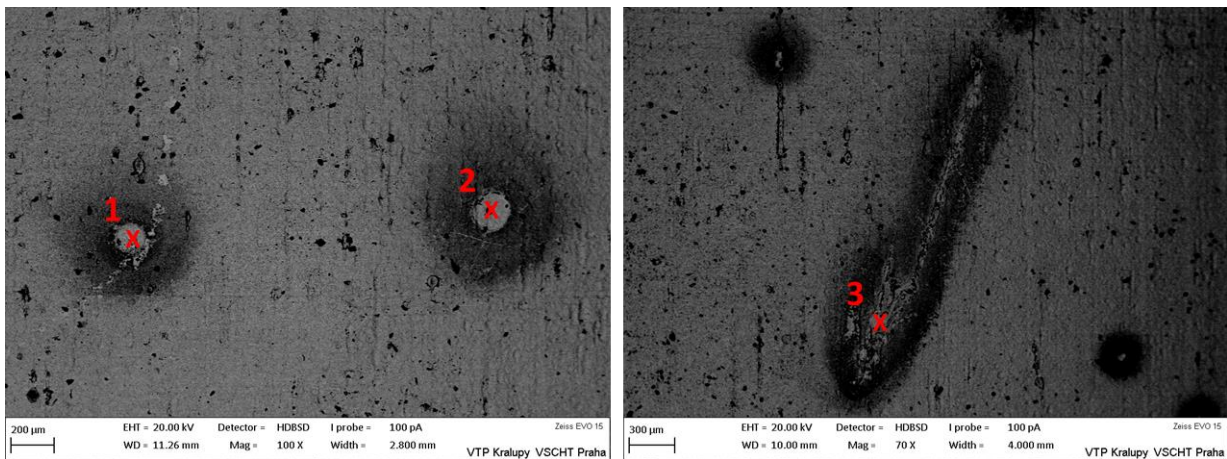
**Figure 3.** SEM-EDS analysis of corrosion pits on surface

**Table 1.** Chemical composition in wt. % of pits determined by EDS analysis

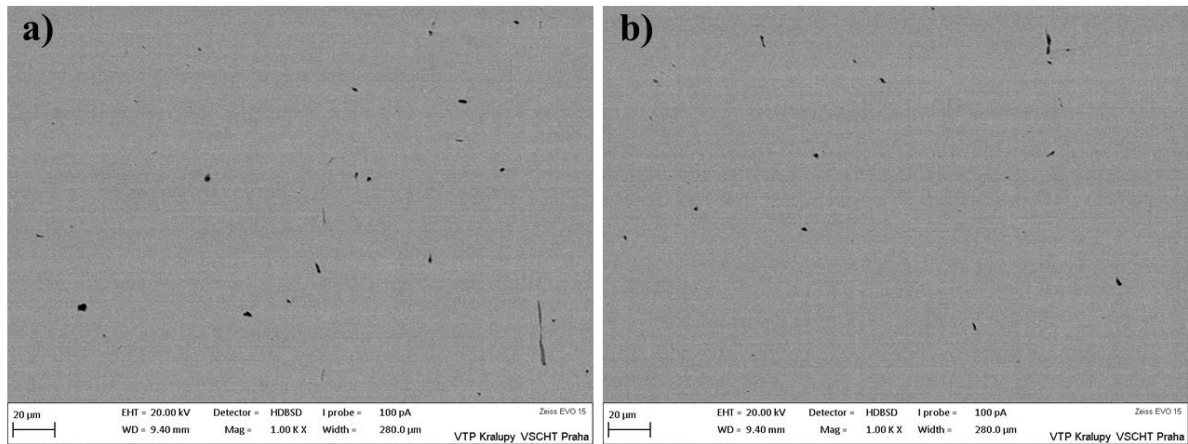
Subsequently, metallographic cross-section analysis was performed. A high number of inclusions was present in the material. Examples are shown in Figure 4. It can be observed that the inclusions have different size and morphology. The average size of the inclusions is in the order of units of  $\mu\text{m}$ . The chemical composition of the inclusions was analysed. In addition to carbides mentioned above, aluminium oxide particles (Figure 5) were also identified.

Figure 4. Distribution of inclusions present in sample

An analysis of the delivered gun barrel steel rod was carried out. Corrosion pits were observed over the entire surface of the sample. A large number of inclusions was present in the material. Their size was typically of several micrometres in diameter. The analysis of the chemical composition showed that the inclusions were mainly mixed carbides of iron, chromium and manganese as well as aluminium oxide particles. Most probably, the inclusions were responsible for the pitting during acid pickling.

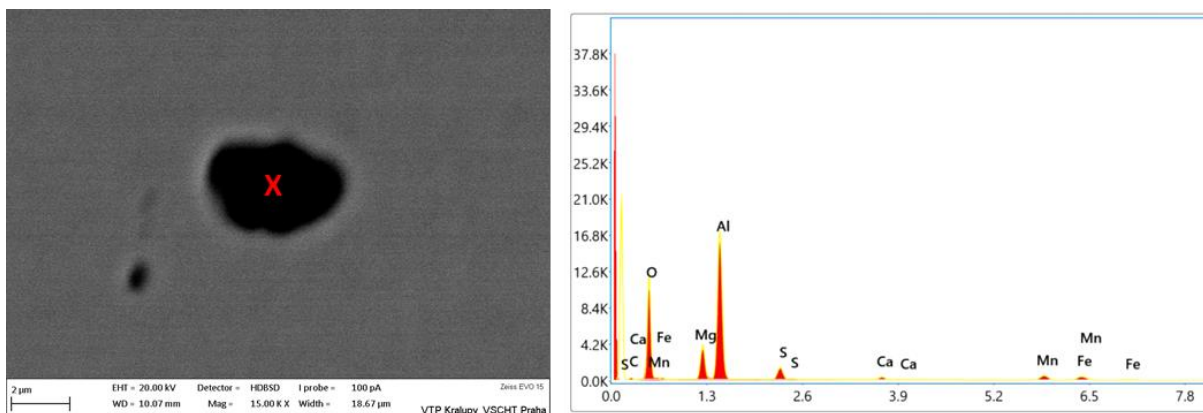
Figure 5. Aluminium oxide particle
